Manhole Inspection Summary

Manhole # S06EE2032MH

Insp Date: **5/15/08 12:38 PM**

Location Address: **GLENGYLE AVE**

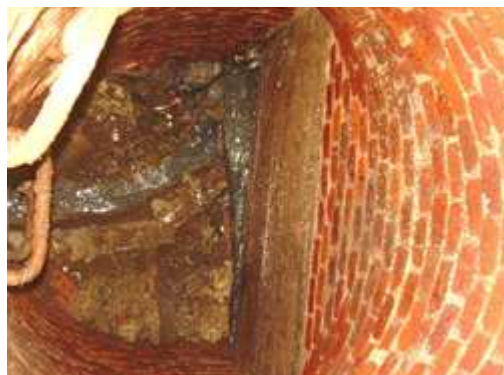
Top View

Corroded steps. Evidence of surcharge - Bench debris.

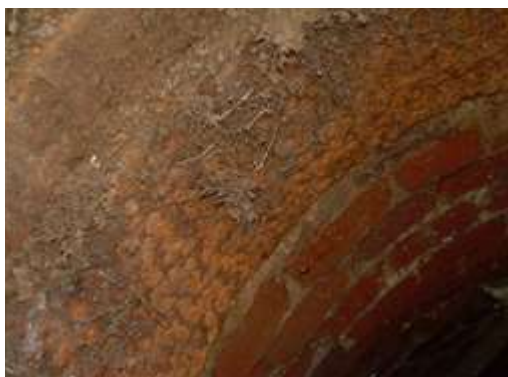
Defect

Adjustment infiltration.

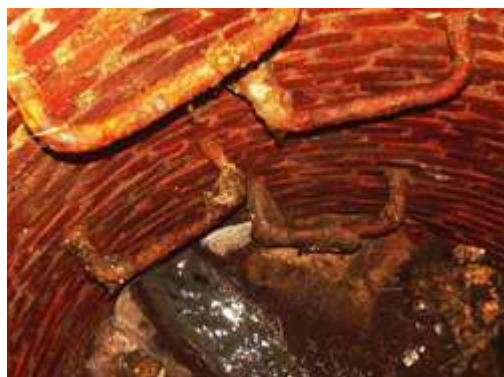
Defect

Corroded steps. Evidence of surcharge - Bench debris.

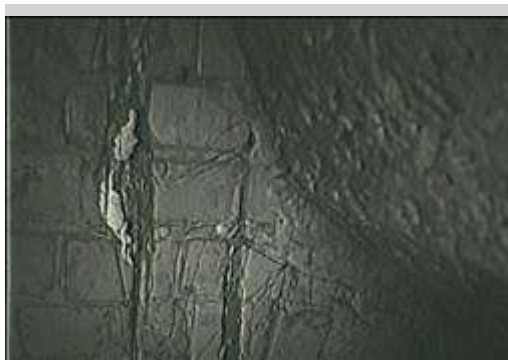
Defect

Barrel root intrusion and infiltration.

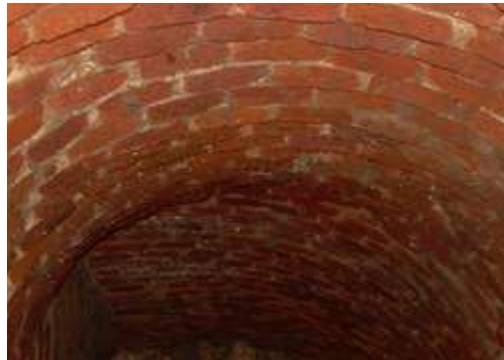
Defect

Barrel infiltration.

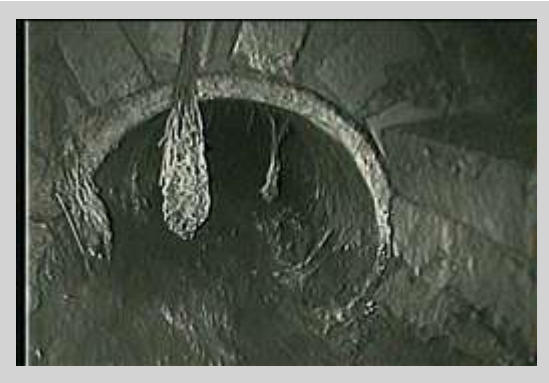
8 in. Circular Gravity Sewer Pipe Out @ 12 O'Clock

Barrel root intrusion and infiltration.

Infiltration: **Evidence** Pipe Seal Cond: **Roots**

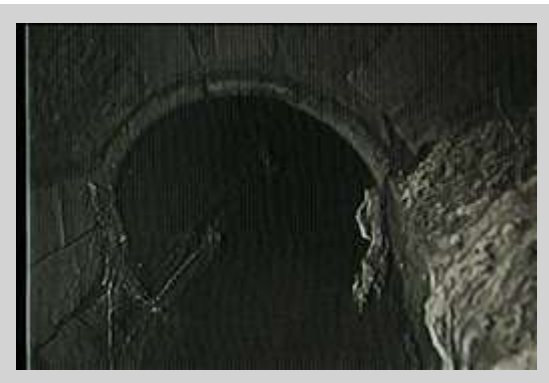
8 in. Circular Gravity Sewer Pipe In @ 6 O'Clock

Channel deterioration and root intrusion.

Infiltration: **Evidence** Pipe Seal Cond: **Roots**

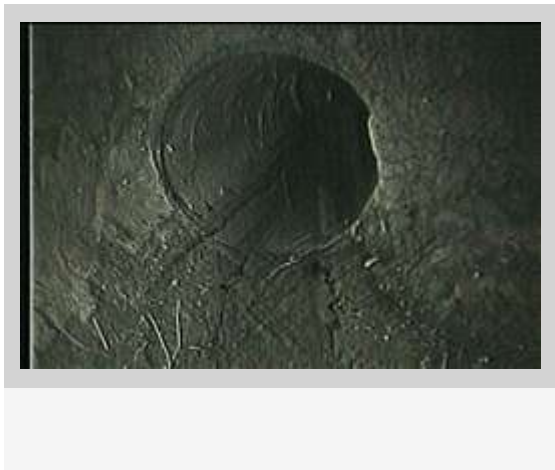
8 in. Circular Gravity Sewer
Pipe In @ 9 O'Clock

Infiltration: **Evidence** Pipe Seal Cond: **Cracked**
